RIOT GLASS, INC.

MIAMI-DADE TEST REPORT

TAS 201, TAS 202, AND TAS 203 TESTING ON AP-25 FULL FRAME MOUNT, PROTECTIVE SYSTEM

L4169.01-303-18

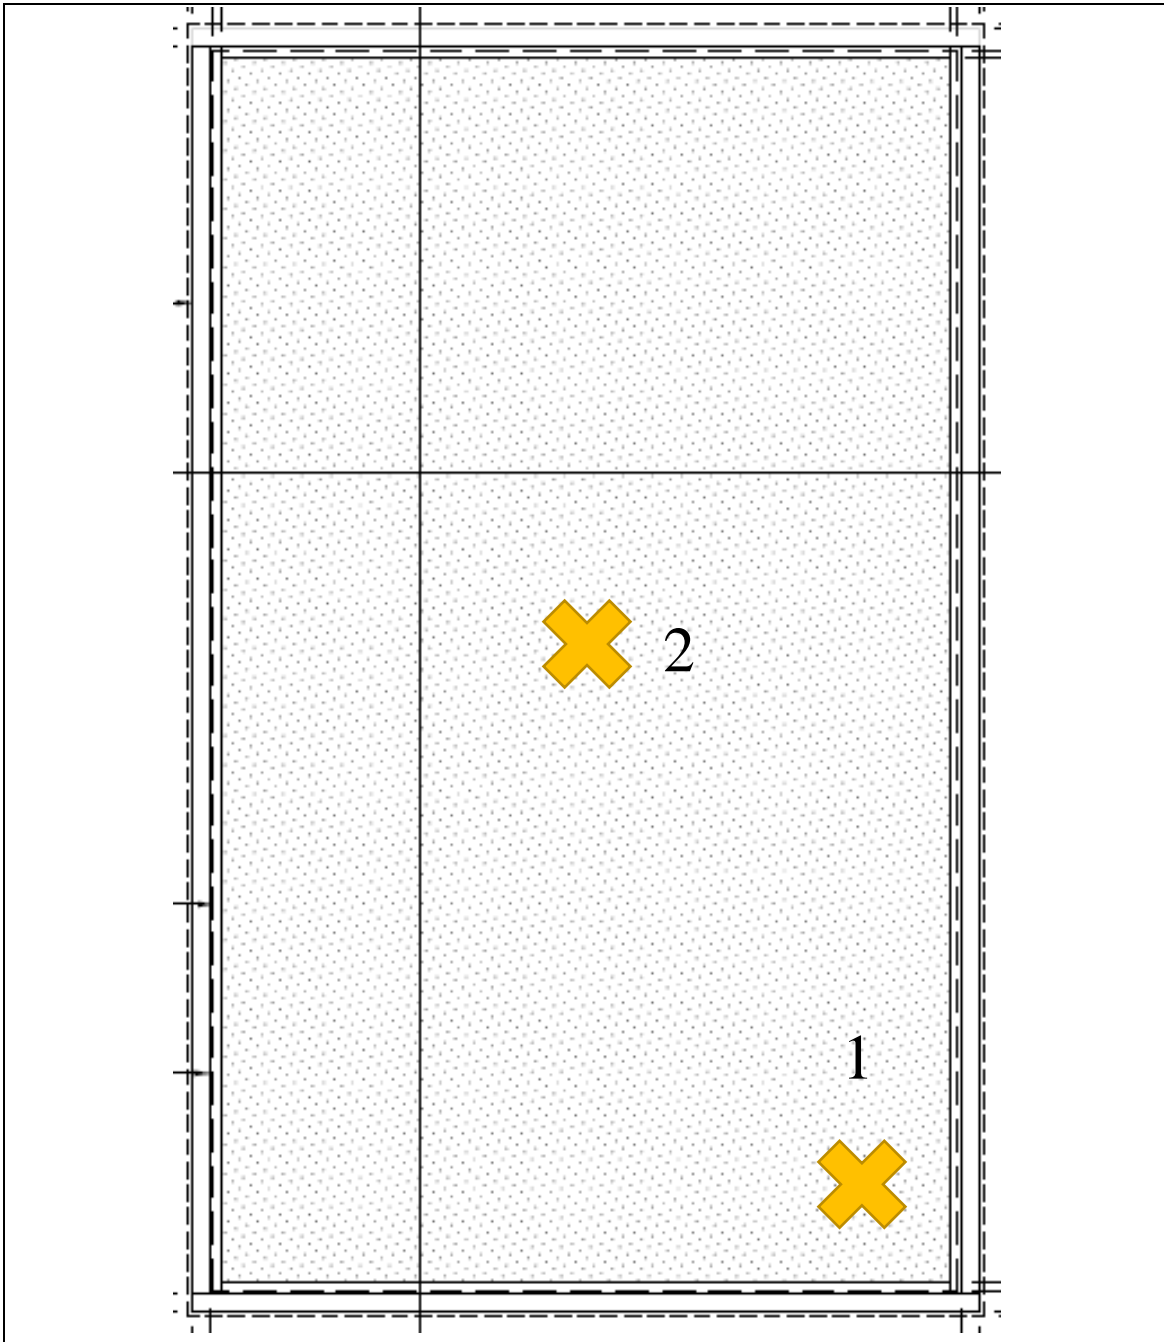
Sketch No. 3

TAS 201 Impact Locations Spec #2

IMPACT #	MISSILE WEIGHT (lbs.)	MISSILE LENGTH (in.)	MISSILE VELOCITY (ft./sec.)
1	9.5	96	49.6
2	9.5	96	50.1

Note 6: See Sketch #2-4 for impact locations.

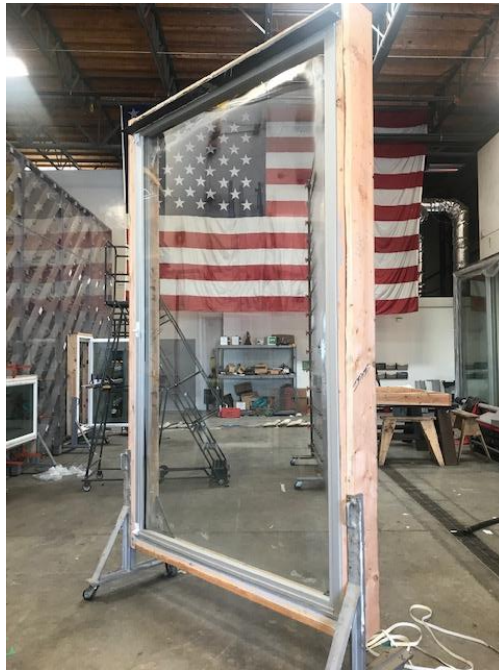
Photo No. 1
Test specimen from exterior

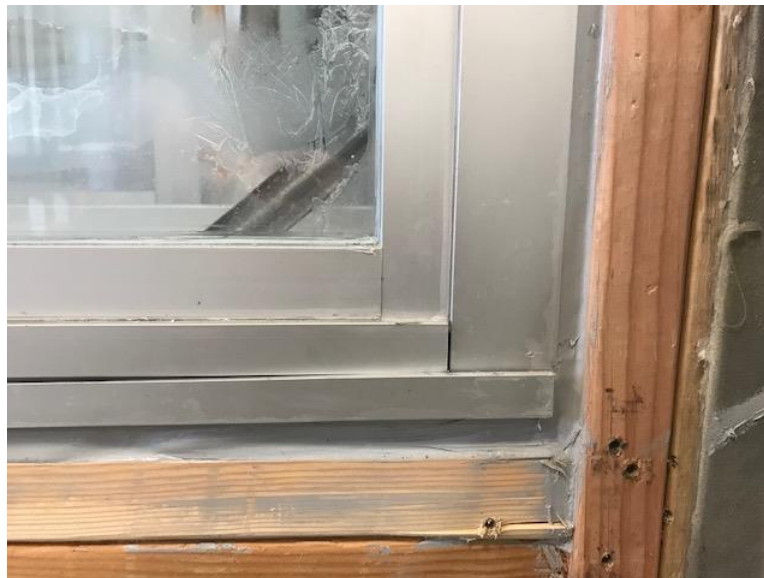
Photo No. 2
Detail photo of corner of AP-25 Installed

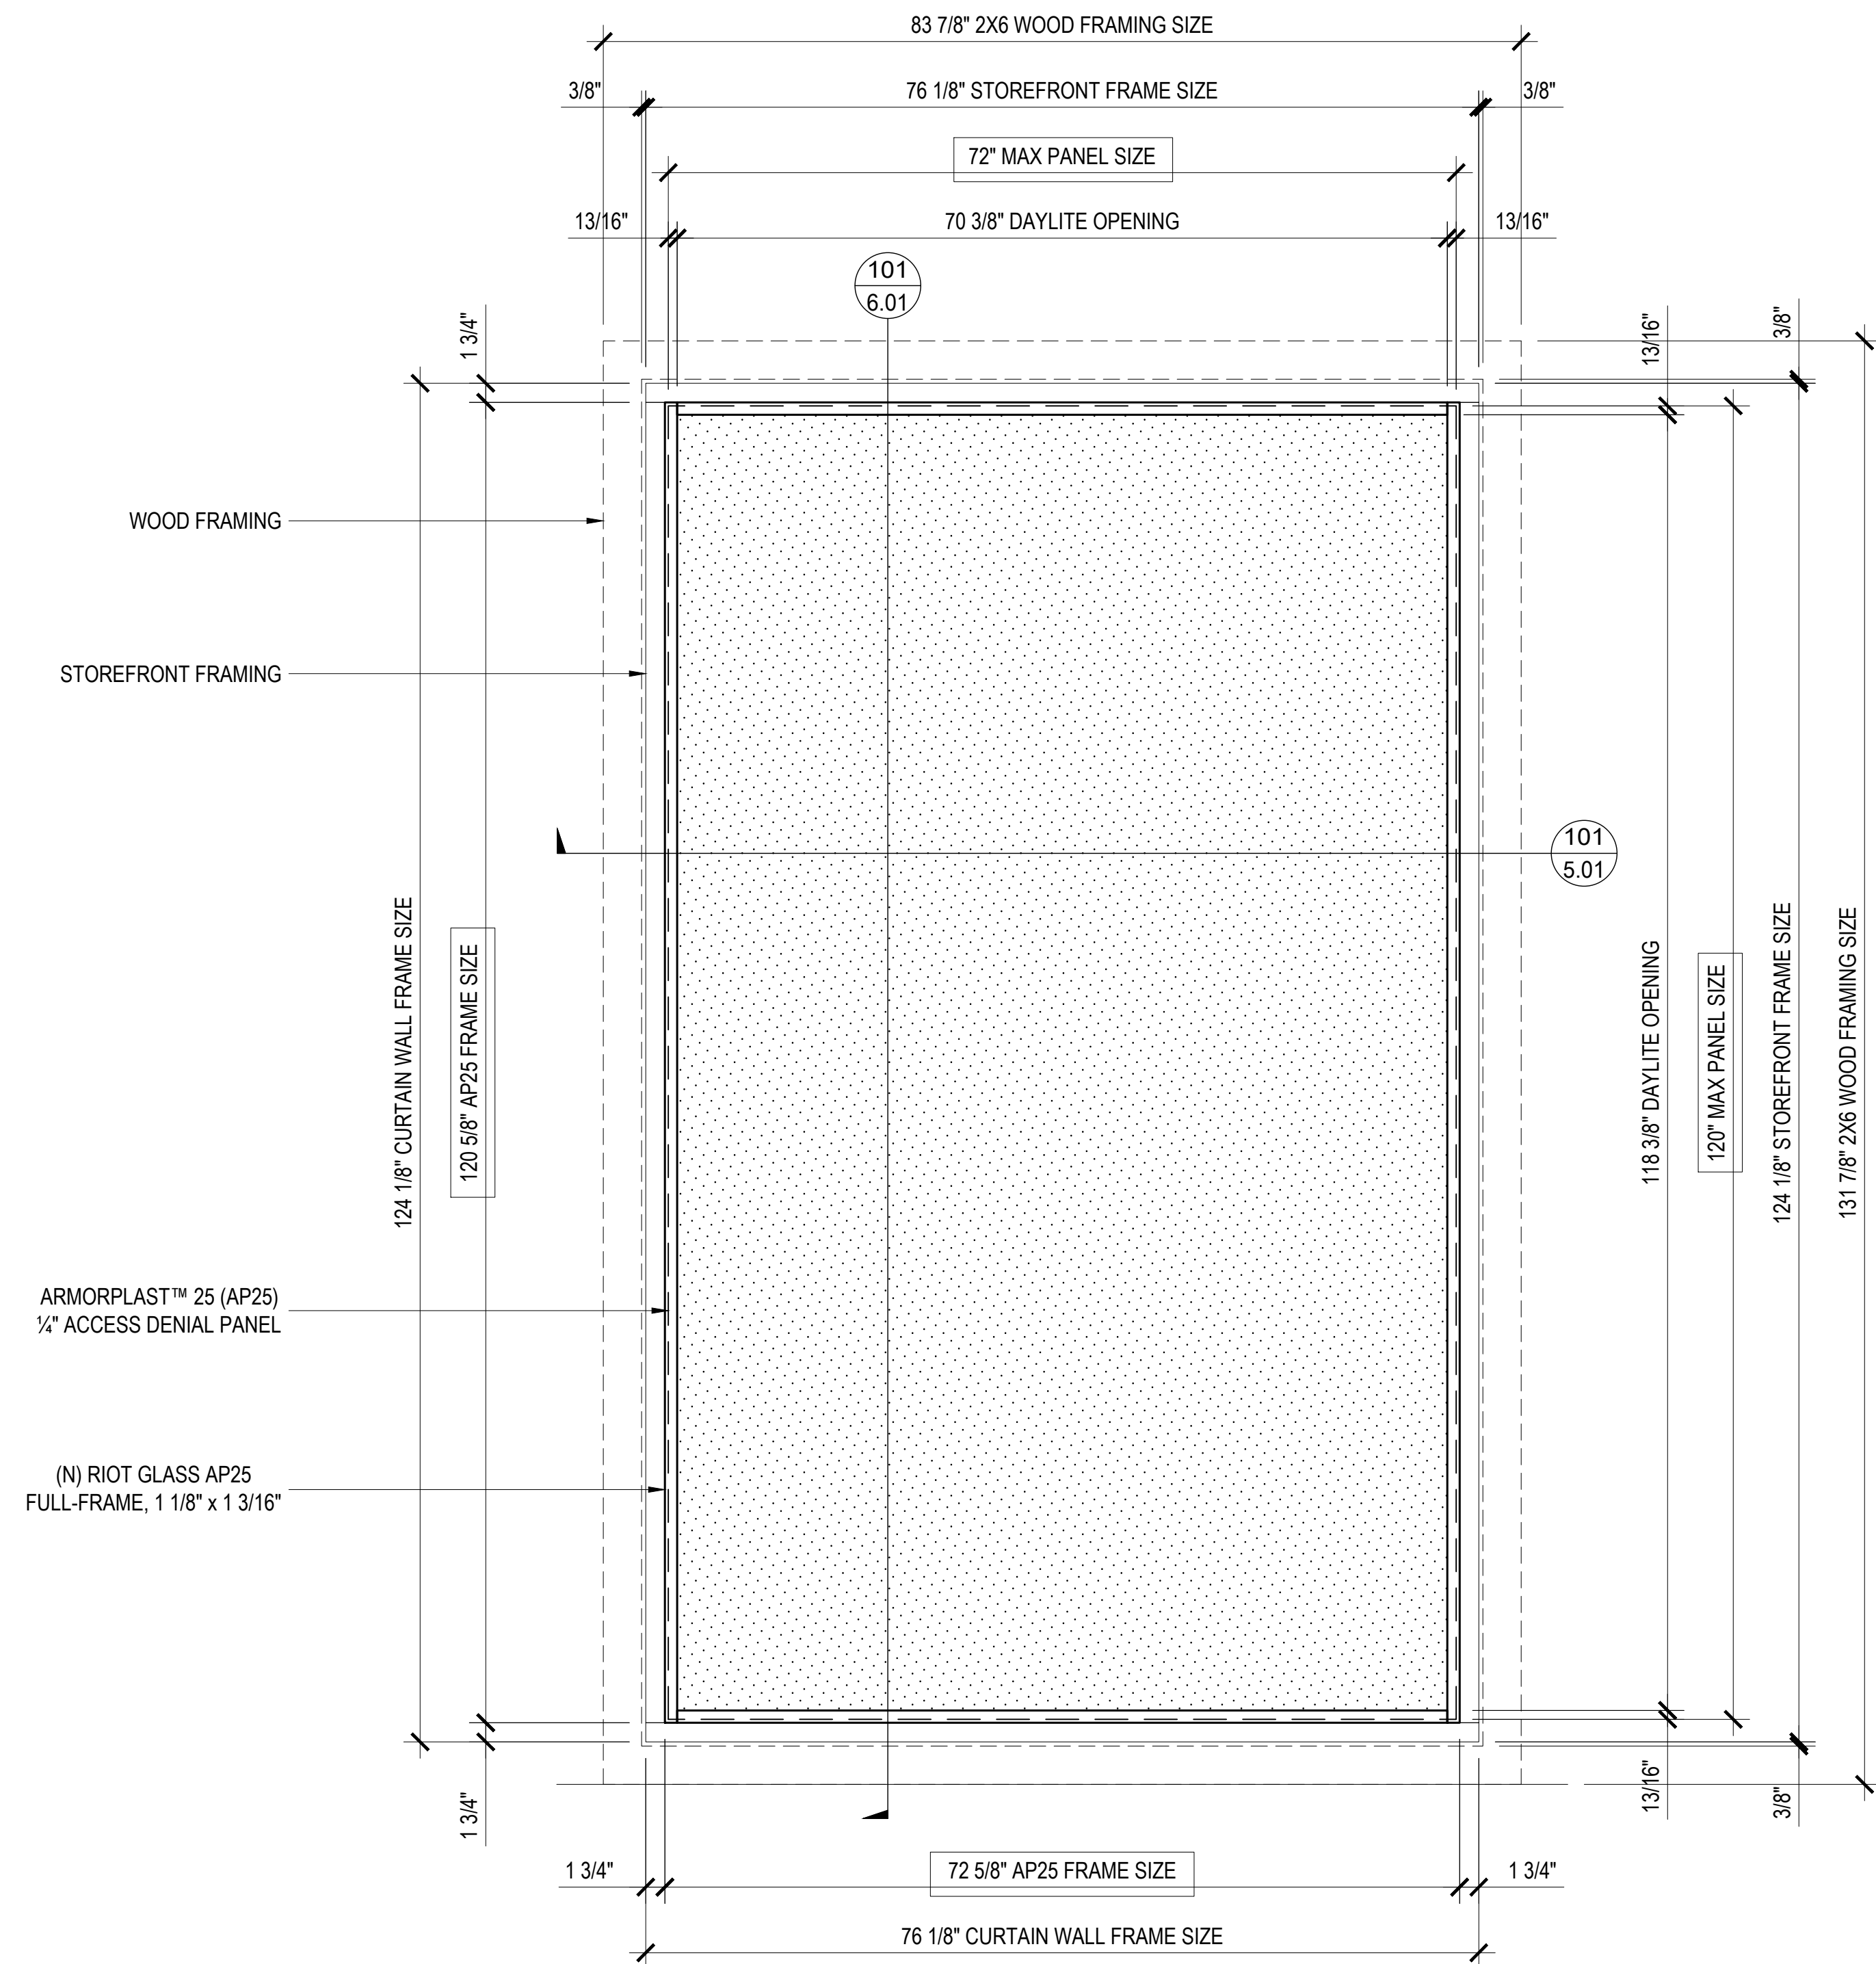
STOREFRONT
ELEVATION
AP-25 FULL FRAME

A	(E) STOREFRONT FRAMING
4 THUS	RIOT GLASS AP25 FULL-FRAME, 1 1/8" x 1 3/16"
	ARMORPLAST™ 25 (AP25) 1/4" ACCESS DENIAL PANEL
	FINISH TO BE DETERMINED

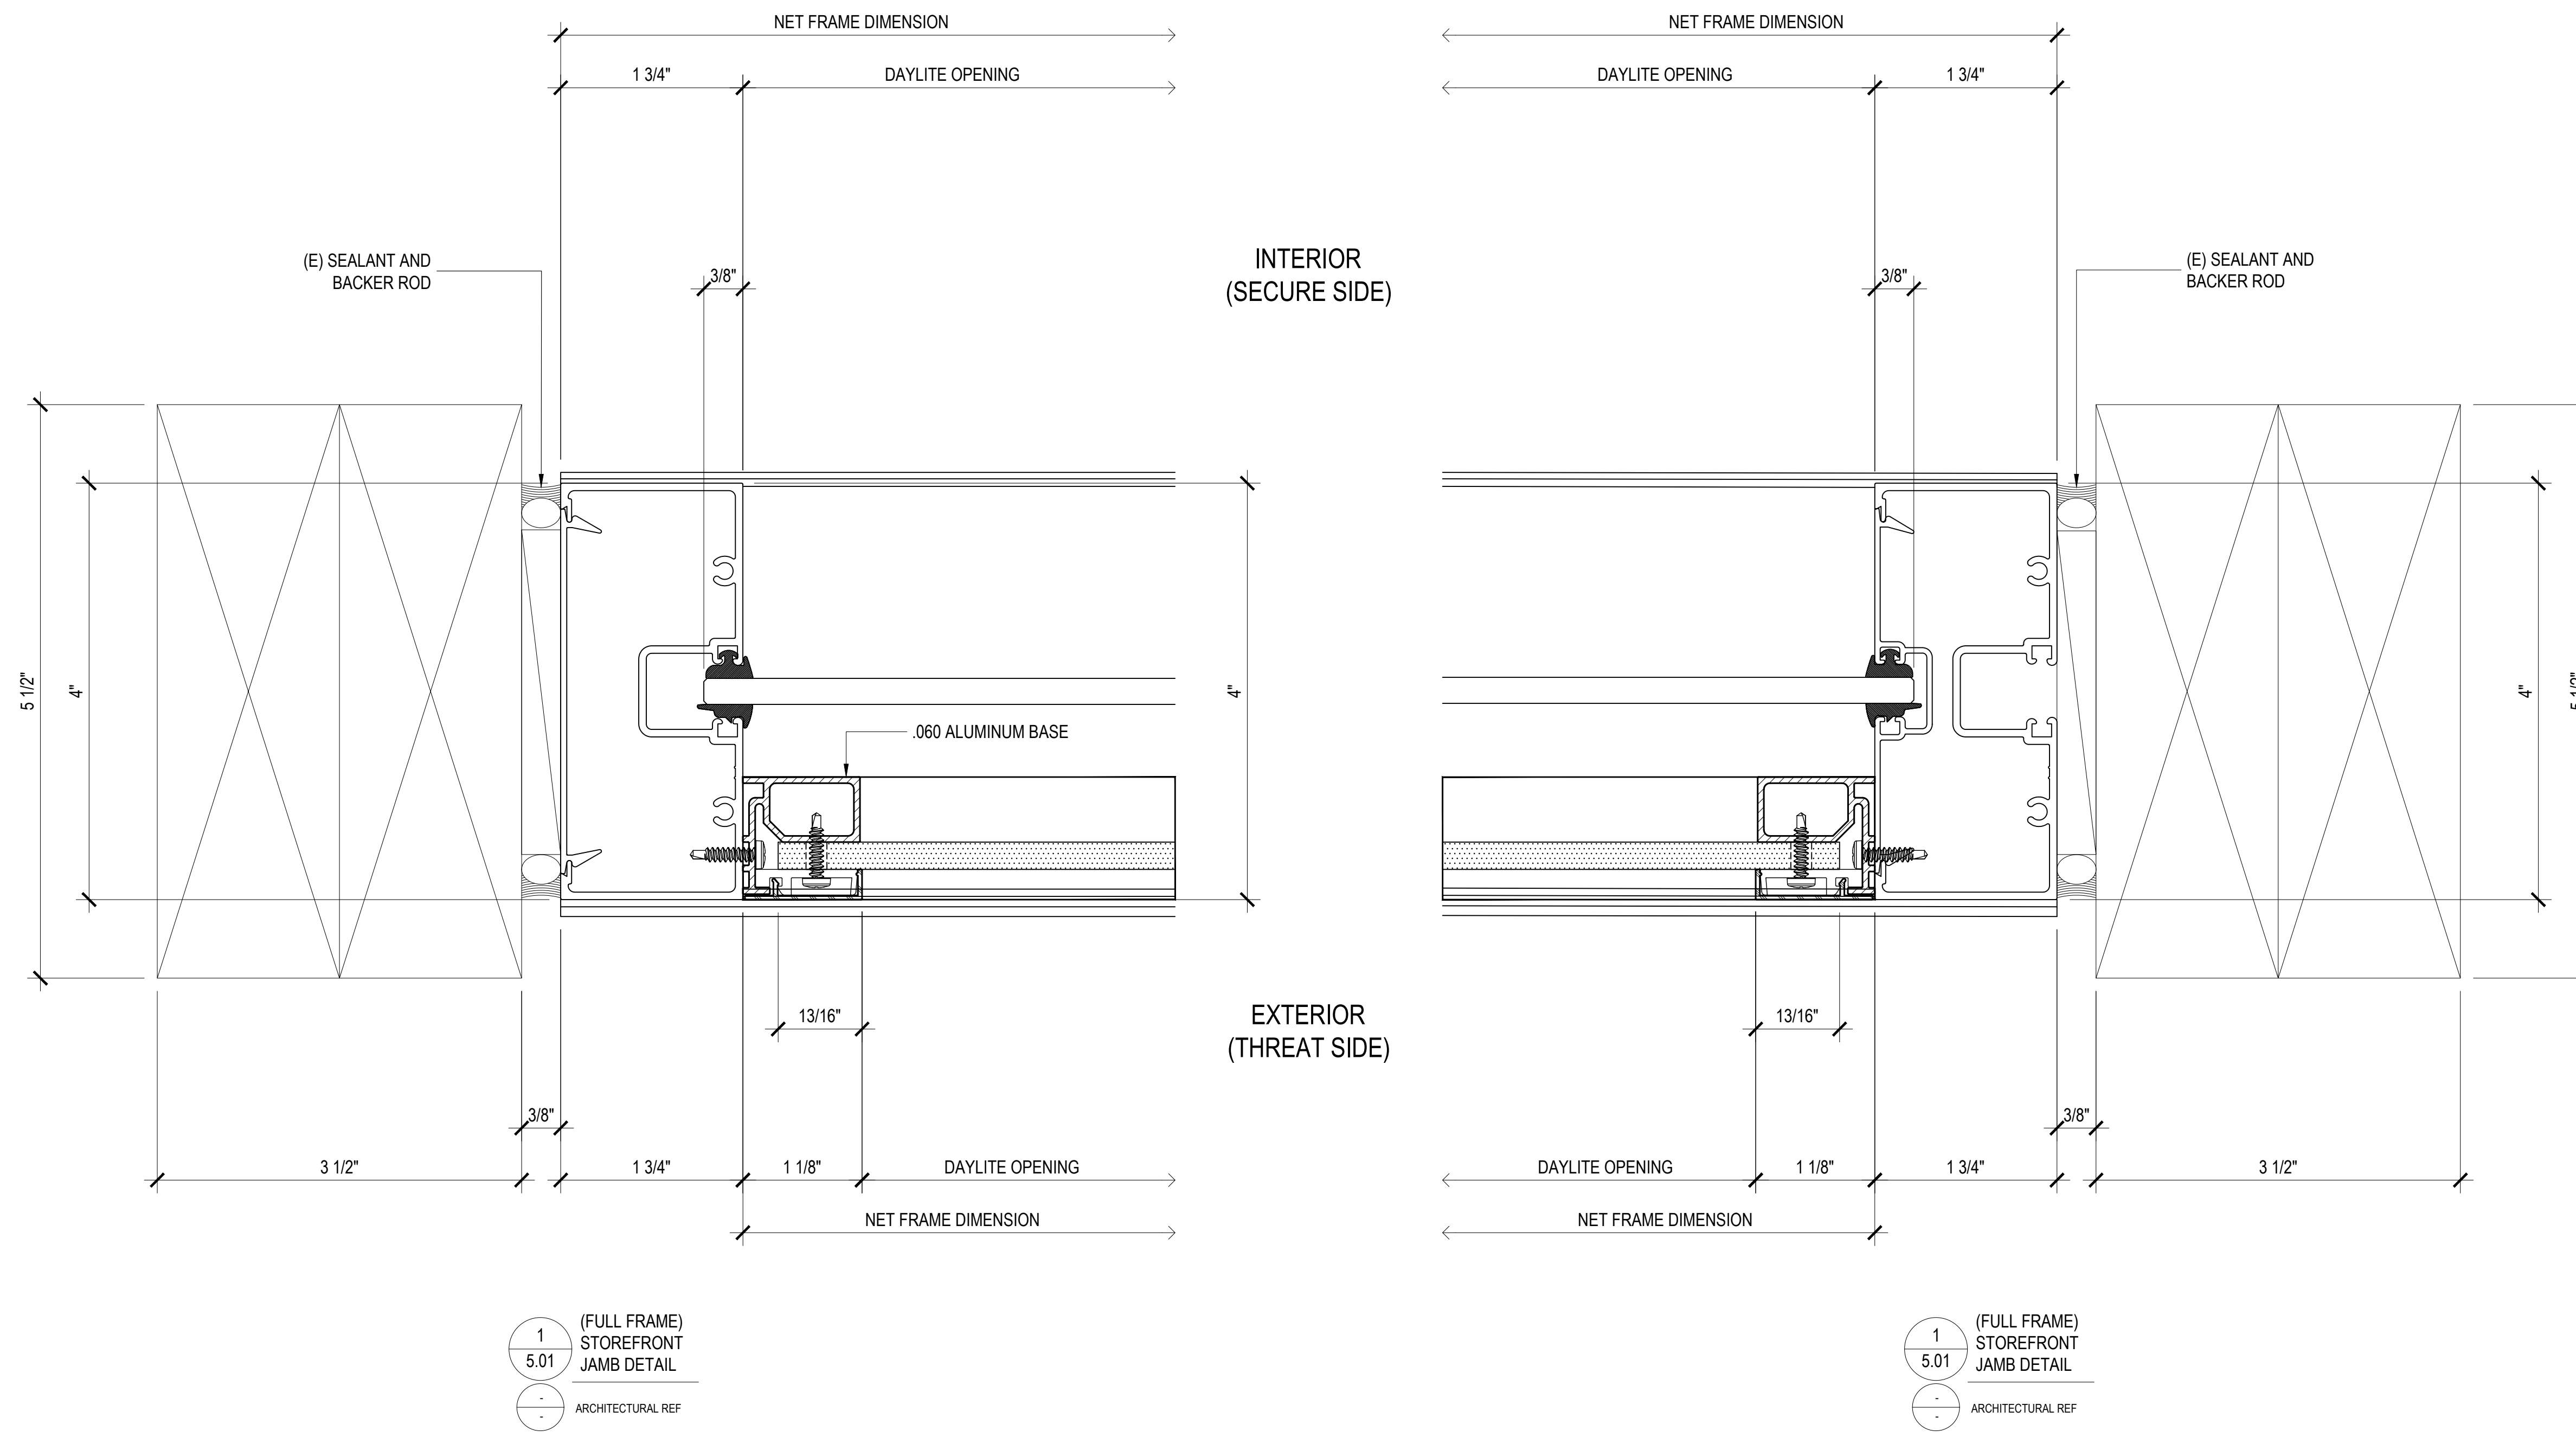
1 (FULL FRAME)
5.01 STOREFRONT
JAMB DETAIL
- ARCHITECTURAL REF

AP-25 FULL FRAME SYSTEM WITH SERIES 450 CENTER / INTERIOR GLAZED STOREFRONT SYSTEM

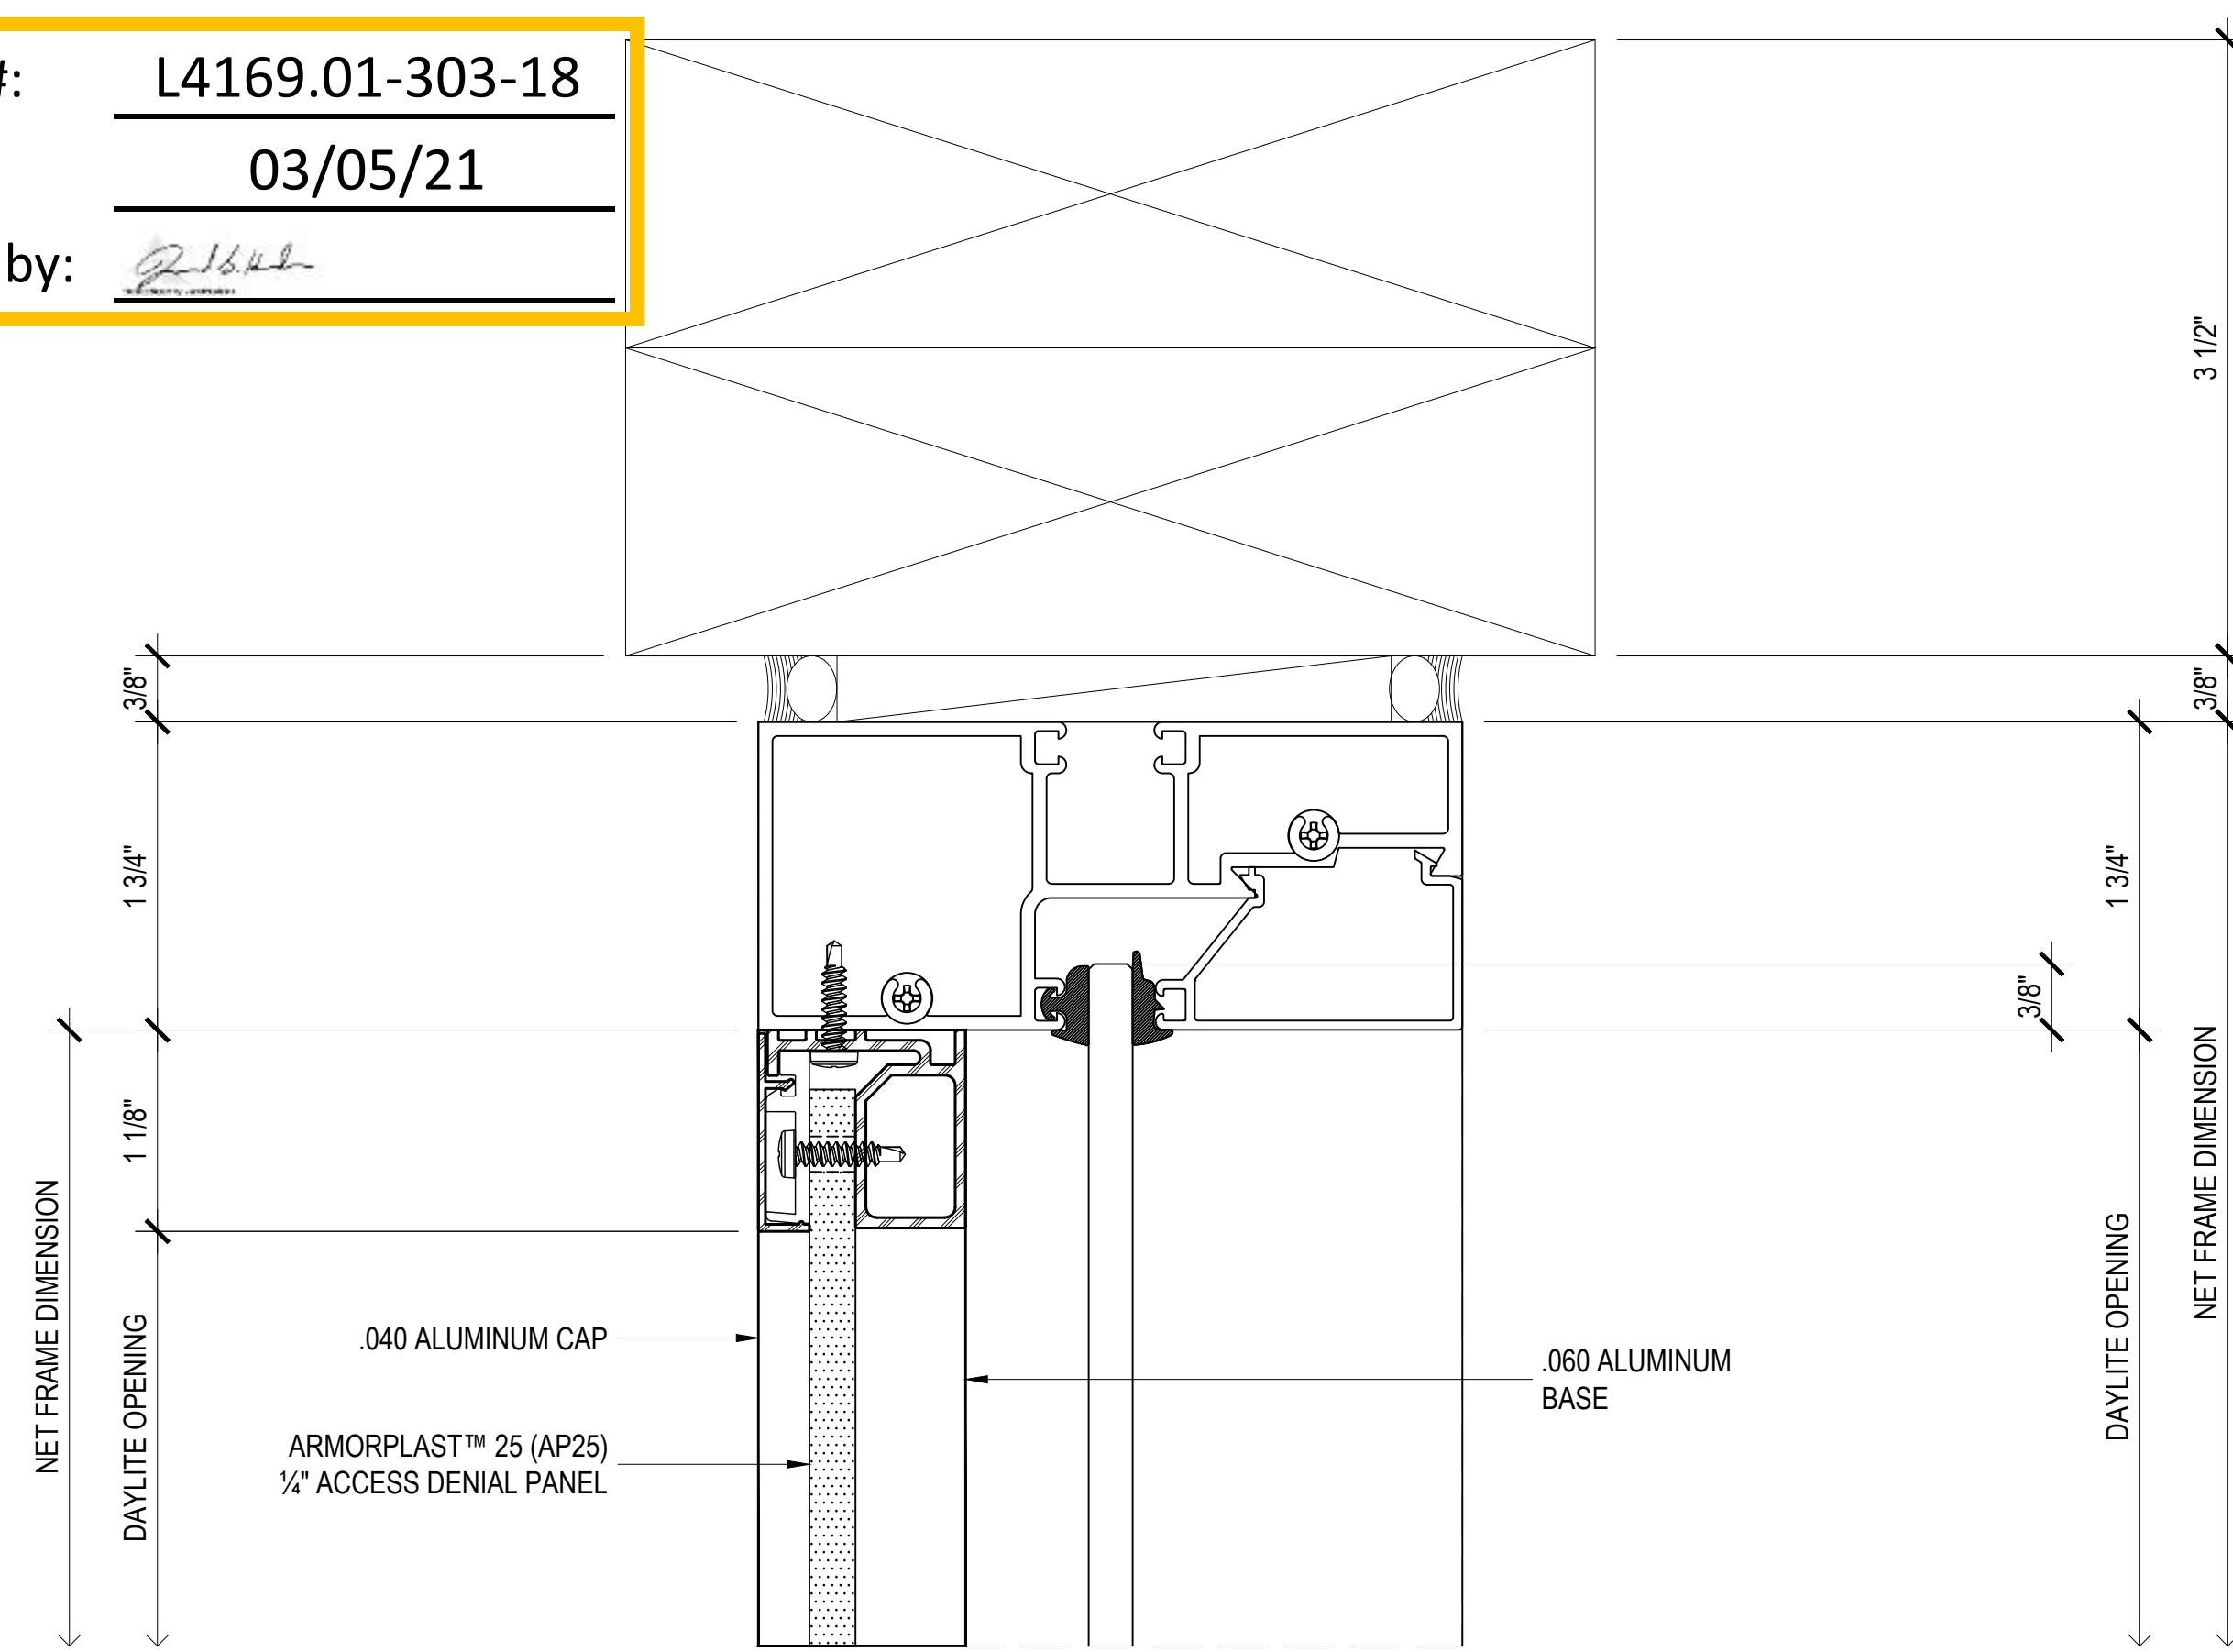
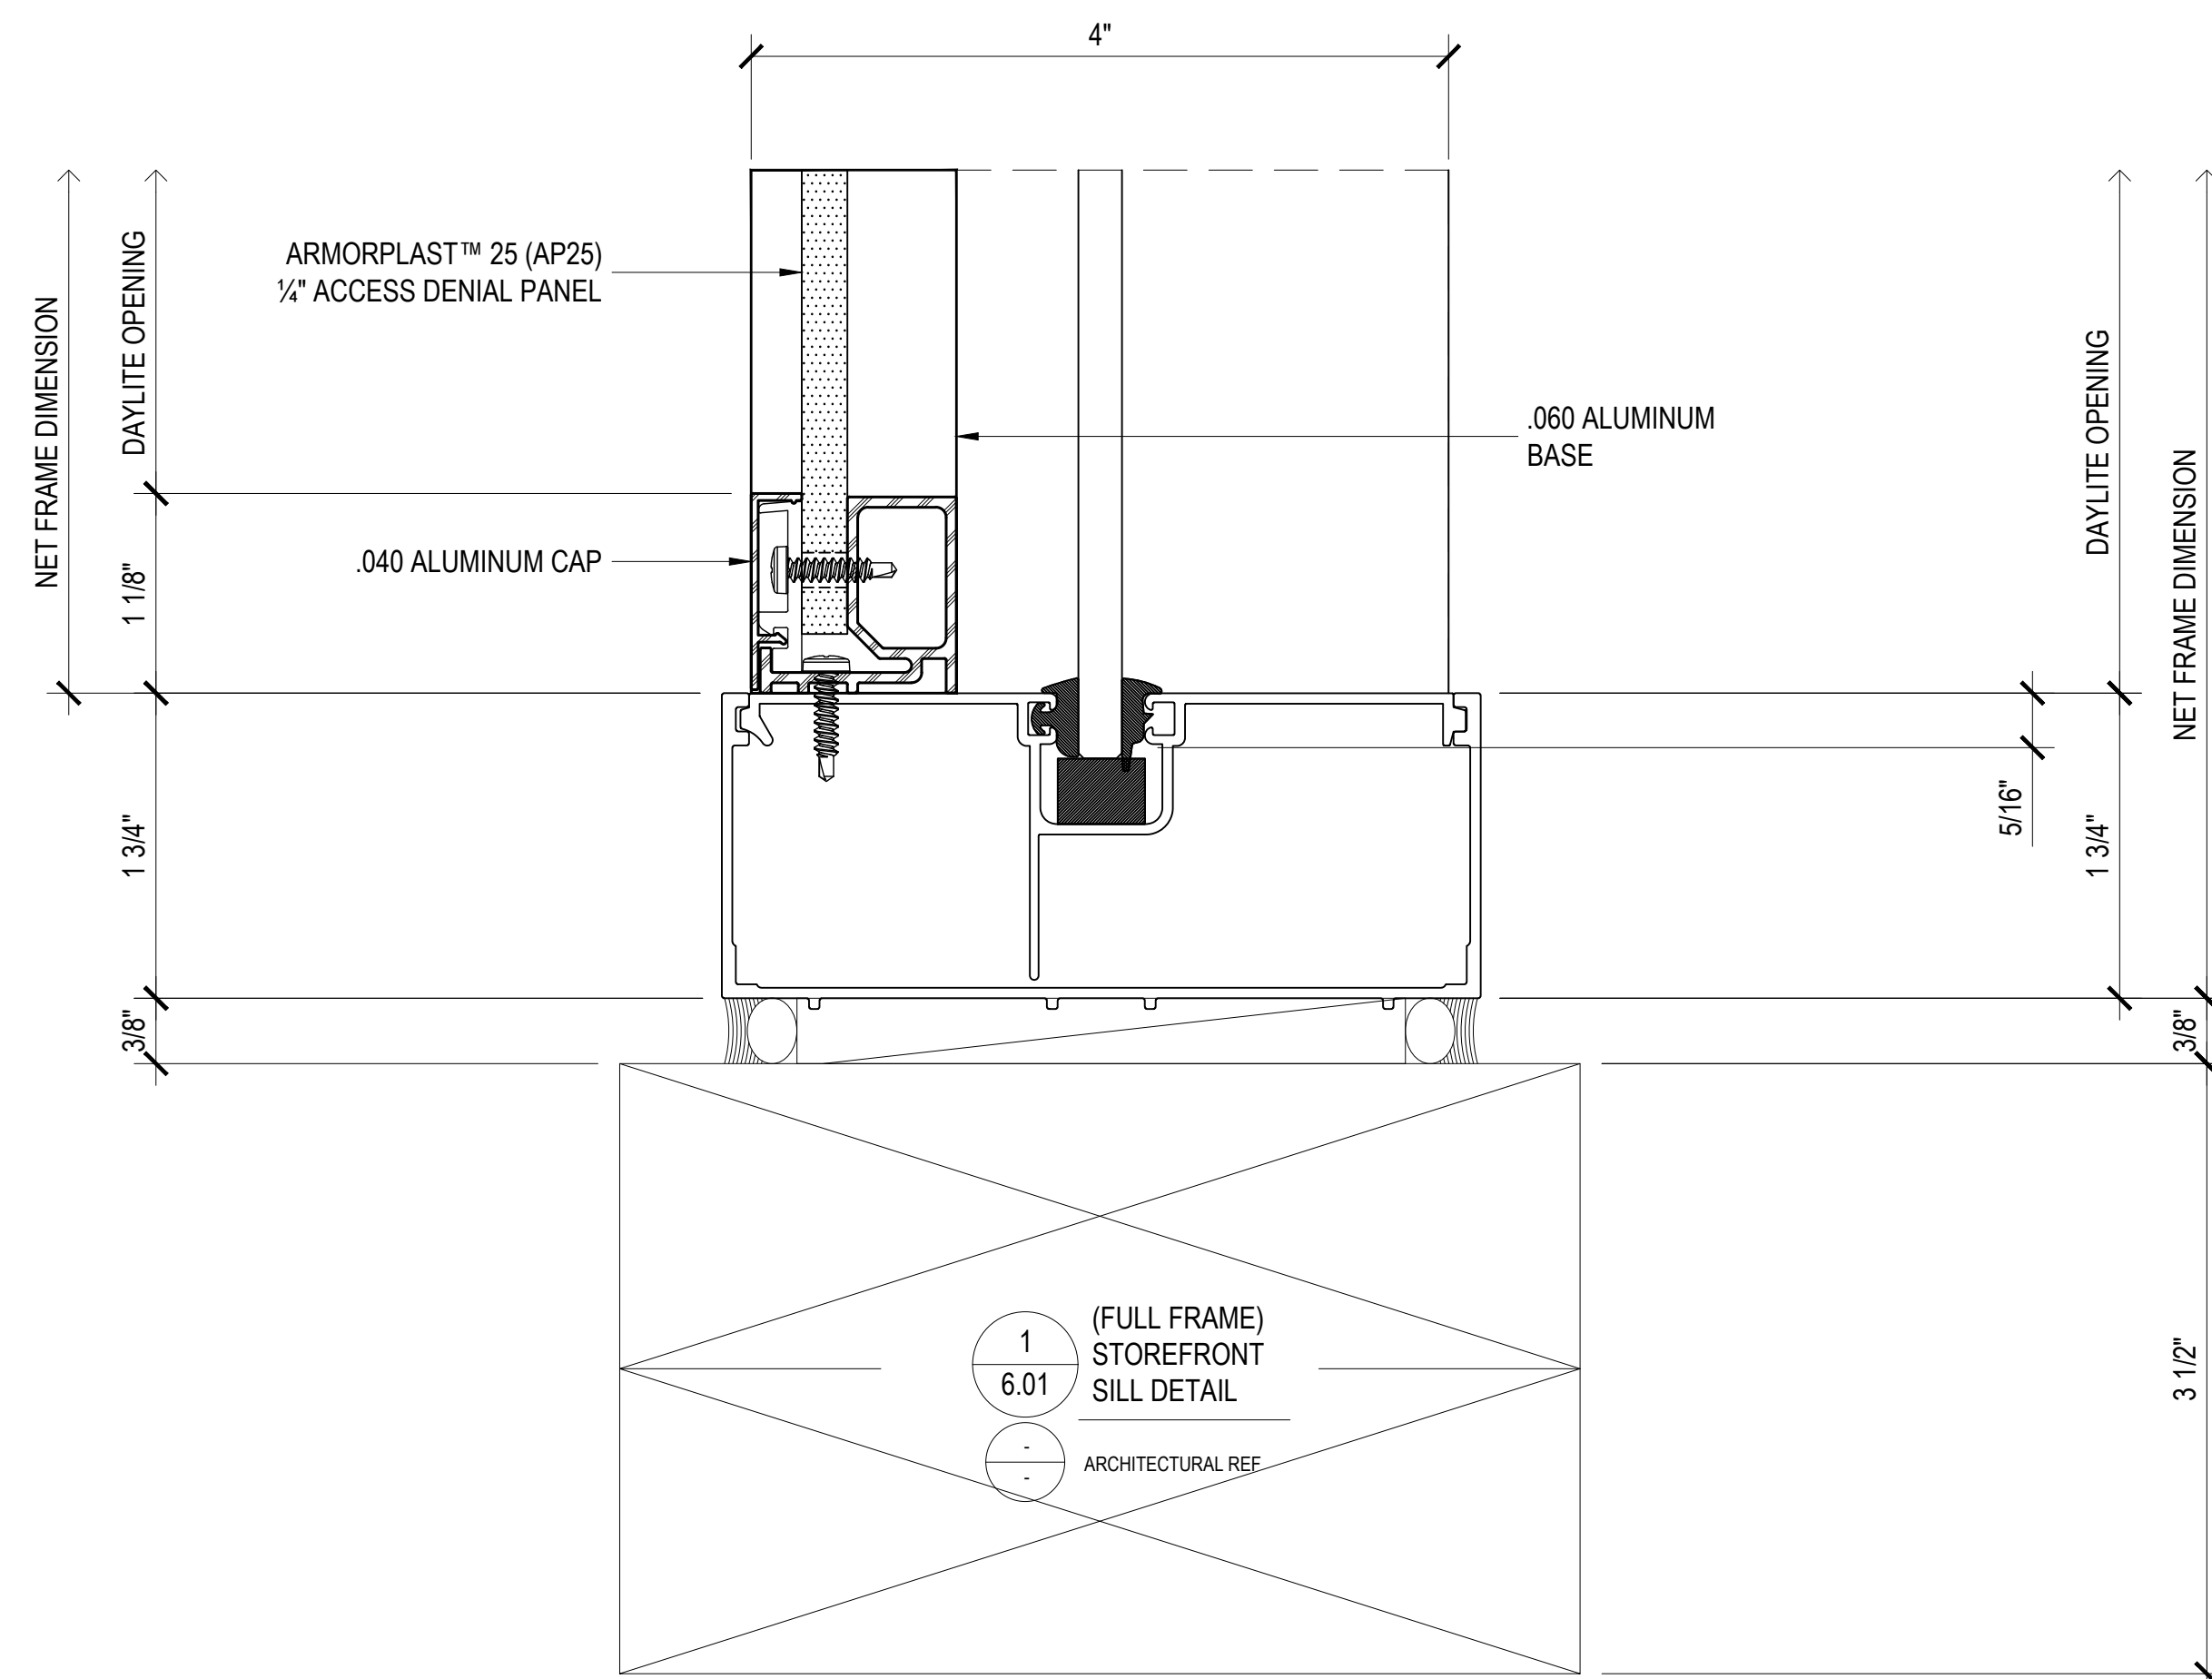
1
6.01
ARCHITECTURAL REF

EXTERIOR
(THREAT SIDE)

INTERIOR
(SECURE SIDE)

AP-25 FULL FRAME SYSTEM WITH SERIES 450 CENTER / INTERIOR GLAZED STOREFRONT SYSTEM
